CITY OF DORAL

ADAPTIVE REUSE

ACTION PLAN

**MAY 2019**

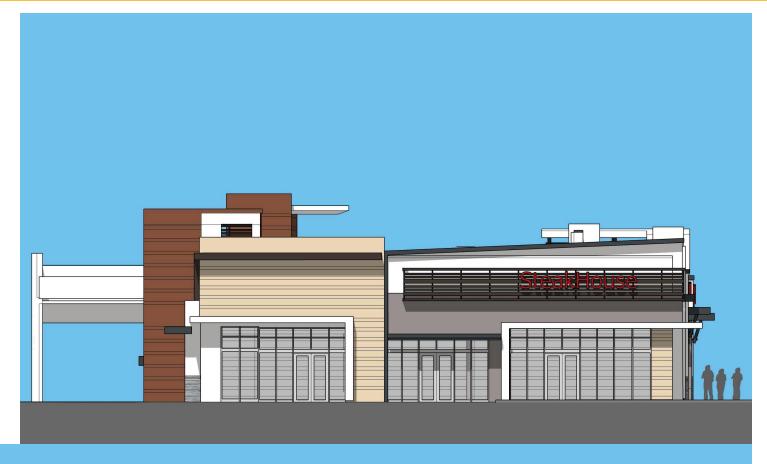
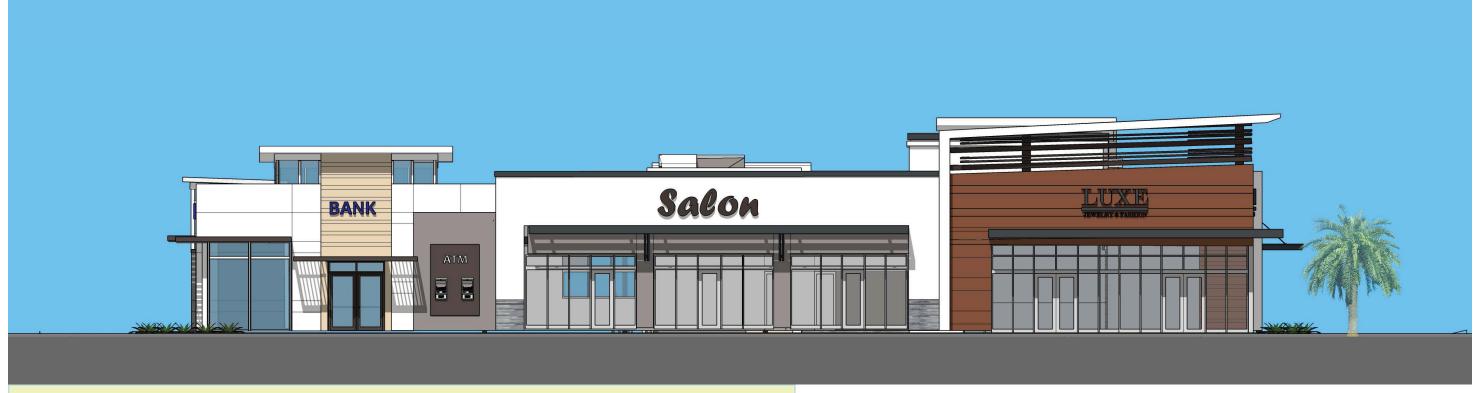
Figure 2-2: New Commercial Development at SE corner of NW 87th Ave and NW 56th St. Source: Modis Architects application package for site plan review (August 24, 2018)

Doral 87th Retail Development Details		
Height	2 stories (maximum of 6 allowed)	
Retail Space	46,840 sq. ft.

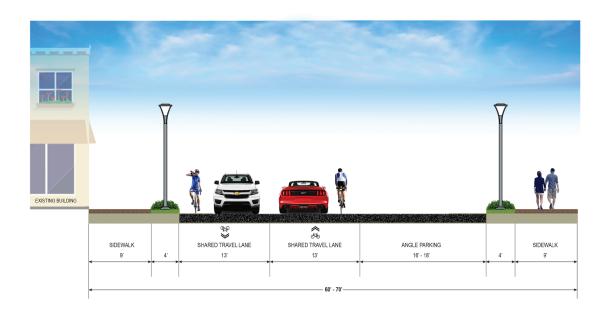
NW 56th Street - Angle Parking

\* Right of way width is approximate and proposed dimensions are meant as guidance. Final roadway design may require modifications to the cross section

**Figure 2-19:** Proposed Street Sections. **Note:** These sections are meant as general design guidance; changes may be required upon more detailed design and engineering evaluations.

See Figure 2-19 illustrating potential configuration of parking and parking alternative recommendations alongside recommendations from the urban design section.

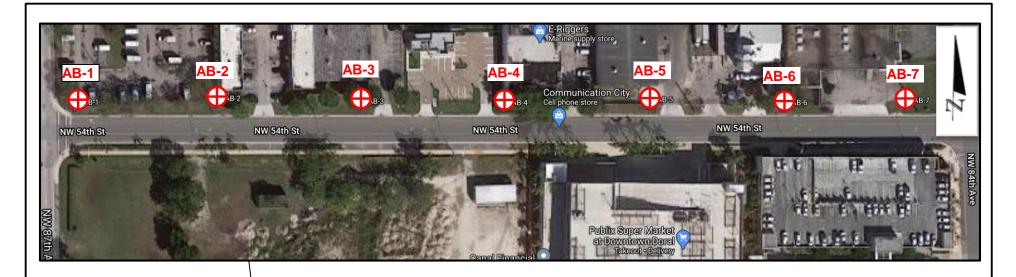
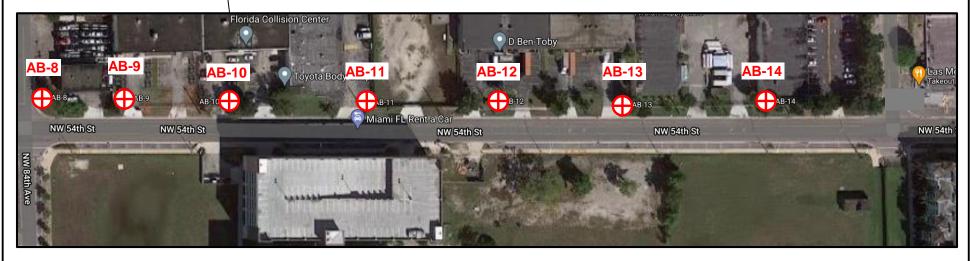
2A

Approximate Boring Location

Roadway Improvements at NW 84th Ave, NW 82nd Ave, NW 54th St and NW 56th St City of Doral, Florida FIG

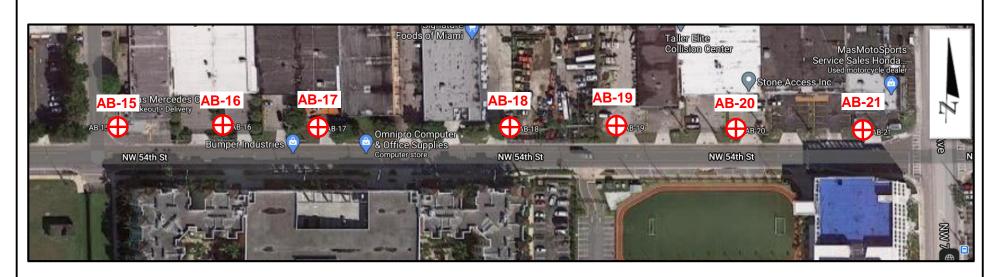
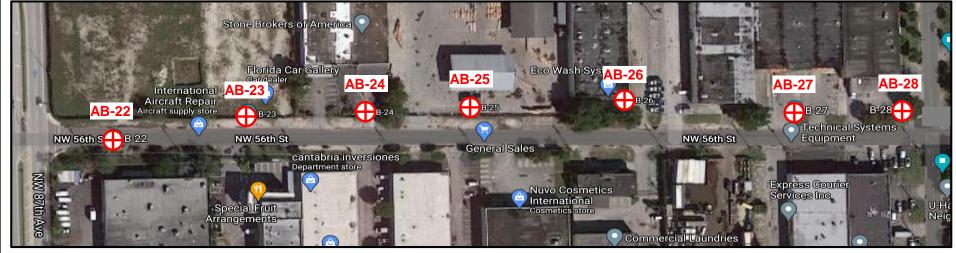
2B

Approximate Boring Location

Roadway Improvements at NW 84th Ave, NW 82nd Ave, NW 54th St and NW 56th St City of Doral, Florida FIG

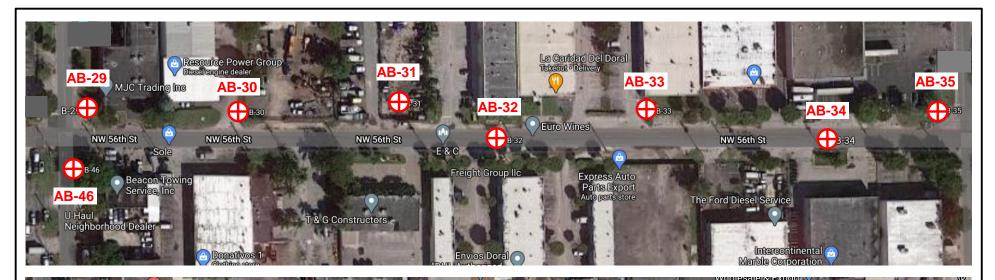
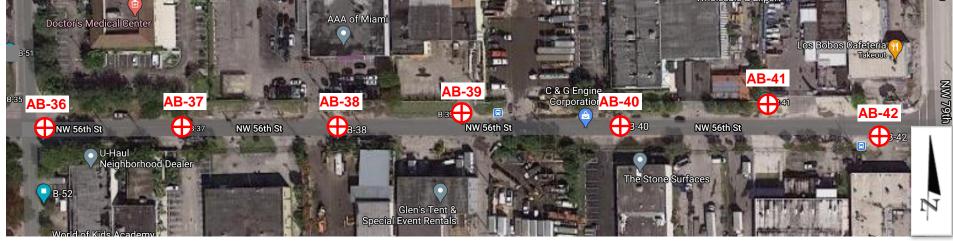
2C

Approximate Boring Location

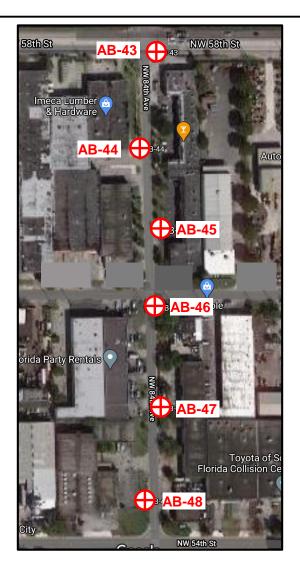
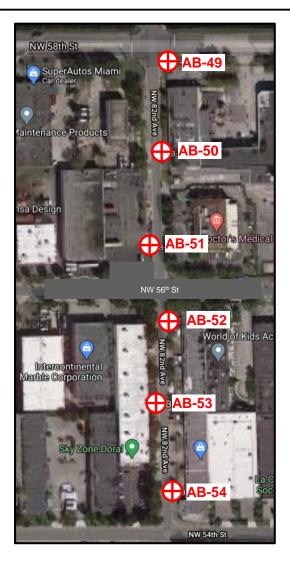
2D

Approximate Boring Location

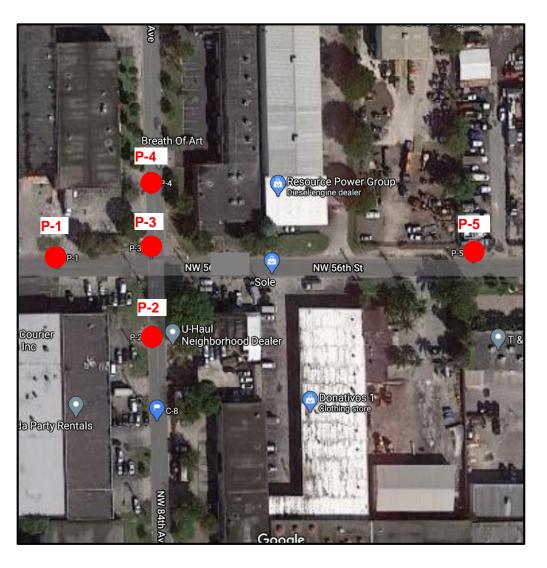
Approximate Exfiltration Test Location

The exfiltration tests were performed in general accordance with SFWMD procedures for the "Usual Condition Constant Head" Exfiltration Tests. The constant-head exfiltration test were performed at the locations indicated on the Summary of Exfiltration Test Locations in Table 1D provided in Appendix C. The approximate test locations are also shown on the Exfiltration Test Location Plan, Figures 2E and 2F in Appendix A.

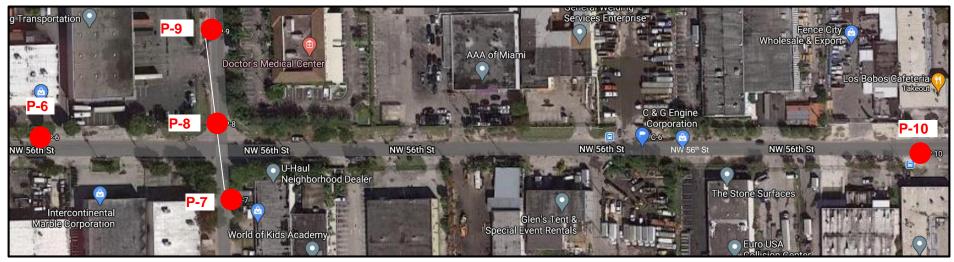
2F

Approximate Exfiltration Test Location

Roadway Improvements at NW 84th Ave, NW 82nd Ave, NW 54th St and NW 56th St City of Doral, Florida FIG

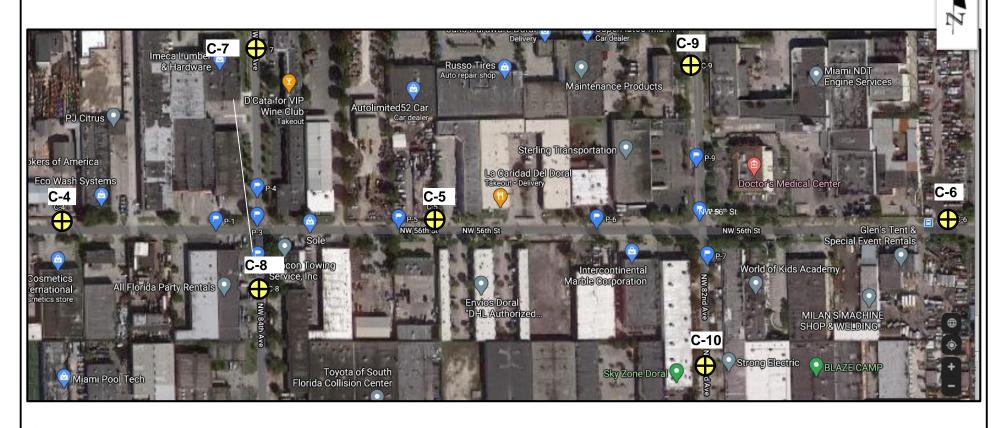
2G

Approximate Pavement Core Location

Upon reaching the surface of the base materials, the coring process was terminated and the pavement core was retrieved. The total thickness of the asphalt pavement was measured and recorded. Upon completion, all pavement cores were patched with cold asphalt concrete patch. The field cores were labeled in the field, visually observed by our field technician to record the condition of the cores and wrapped with masking tape.

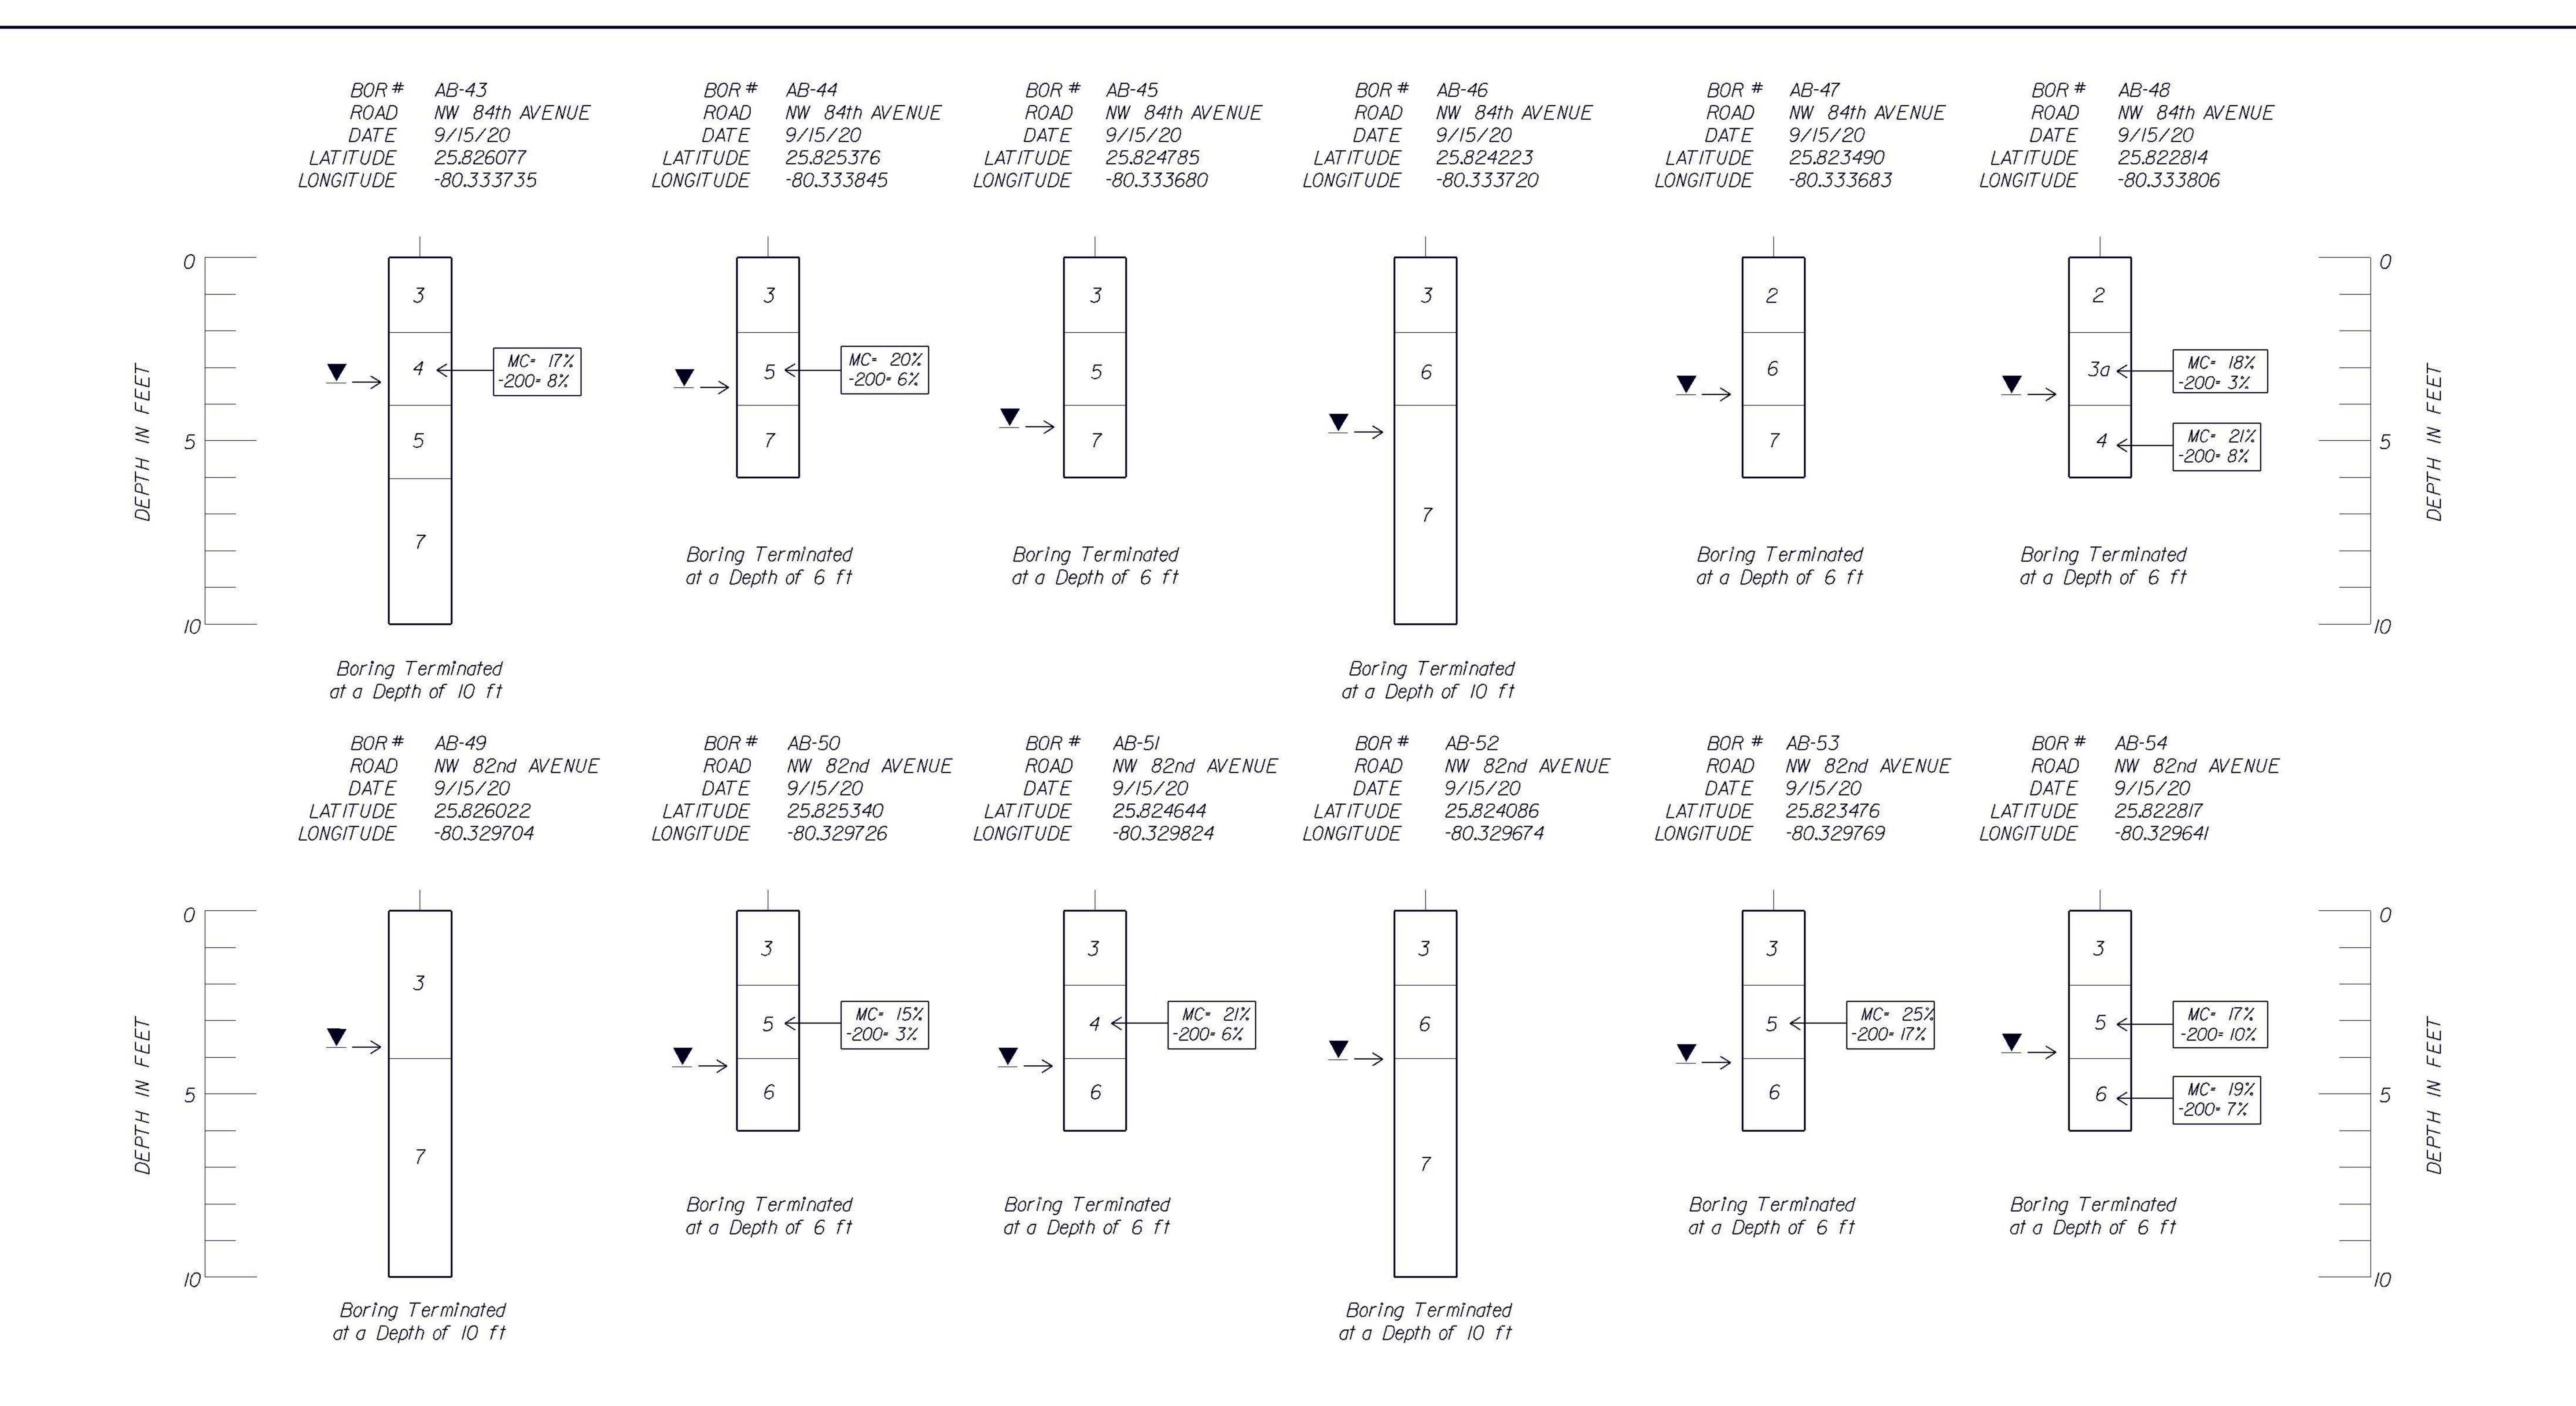
ROADWAY SOIL PROFILE
Roadway Improvements at
NW 84th Ave, NW 82nd Ave,
NW 54th St, AND NW 56th St

- I TOPSOIL (A-8)
- 2- DARK BROWN SILTY FINE SAND, TRACE ORGANICS AND LIMEROCK FRAGMENTS (FILL)(A-8)
- 3- BROWN / TAN SILTY FINE SAND, WITH LIMEROCK FRAGMENTS (FILL) (A-I-b)
- 4- BROWN FINE SAND WITH SILT (A-2-4)
- 5- BROWN FINE SAND WITH SILT, TRACE LIMESTONE FRAGMENTS (A-2-4)
- 6-TAN / BROWN SILTY FINE SAND WITH LIMESTONE FRAGMENTS (A-2-4)
- 7-TAN LIMESTONE WITH FINE SAND

The results of the SPT tests are presented on the generalized soil profile, Roadway Soil Profile – Sheets 1 through 3 included in Appendix B. These sheets present a generalized soil profile along with groundwater levels. The Soil Profile represent an interpretation of the field log and includes modifications based on a geotechnical engineer's visual classification of the samples returned to the laboratory. The boring locations can be found on the Boring Location Plan, Figures 2A through 2D, in Appendix A. Due to the scale of the drawing, the boring shown on the Boring Location Plan should be considered approximate. A summary of the boring locations performed is presented in Tables 1A through 1C of Appendix C.
